Independent Home Inspections

Property Inspection Report

Sulphur OK 73086-7103

Inspection date: **Tuesday, December 26, 2017**

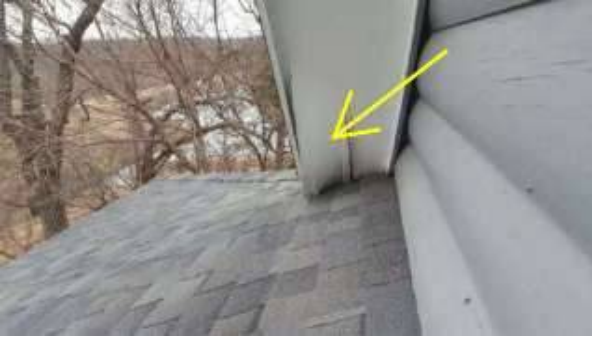
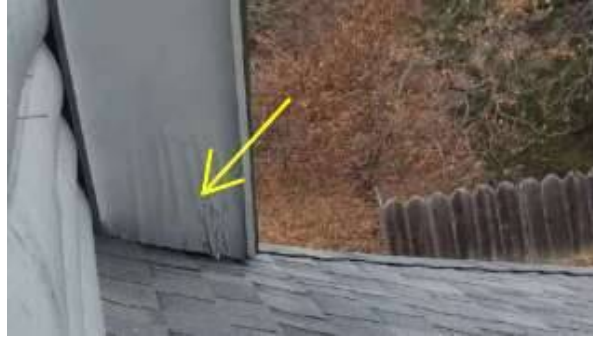
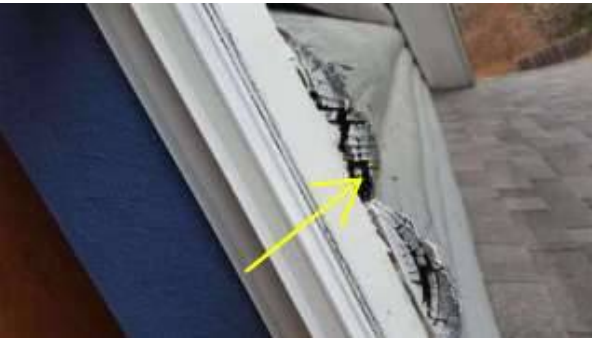
Some sections of siding and/or trim were deteriorated, split and/or damaged. Recommend that a qualified person repair, replace or install siding or trim as necessary.

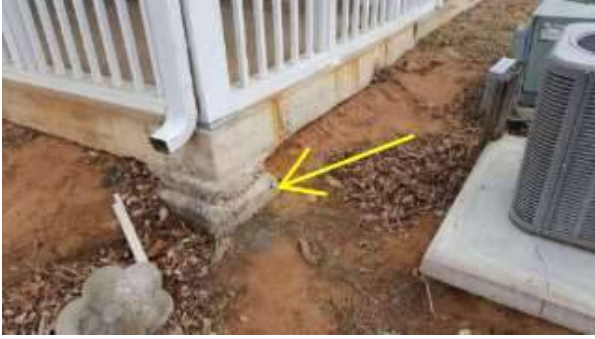
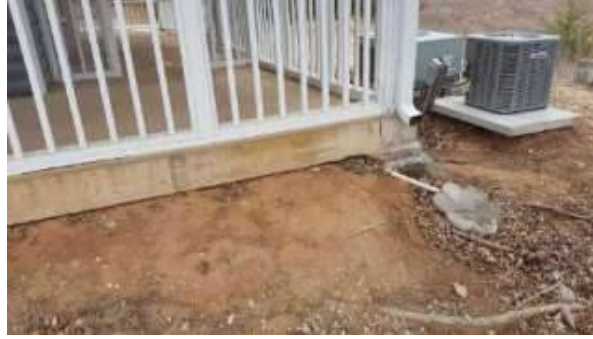
One or more sections of perimeter foundation footings were above grade. Such footings should be below grade so adequate lateral support is provided by the soil. Standard building practices require that perimeter footings are below grade as follows:

- 12 inches or more for one-story buildings
- 18 inches or more for two-story buildings
- 24 inches or more for three-story buildings

Recommend that a qualified person repair as necessary.

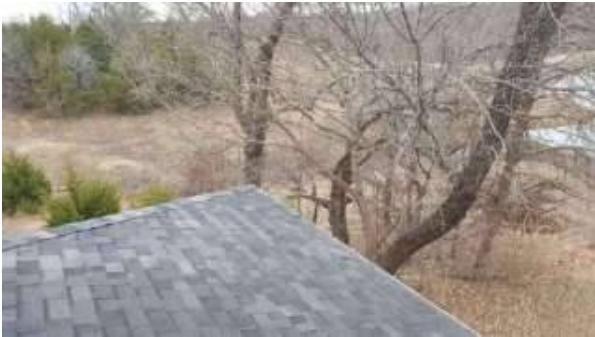
Photo 6-1

Trees were in contact with or were close to the building at one or more locations. Damage to the building can occur, especially during high winds, or may have already occurred (see other comments in this report). Recommend that a qualified tree service contractor or certified arborist remove trees as necessary to prevent damage to the building exterior.

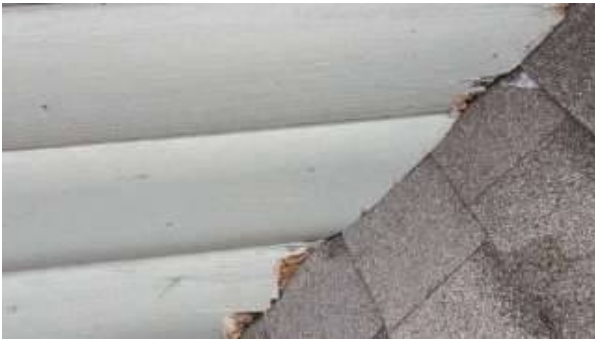
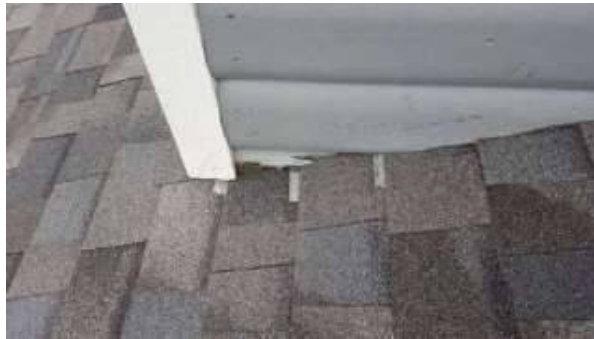
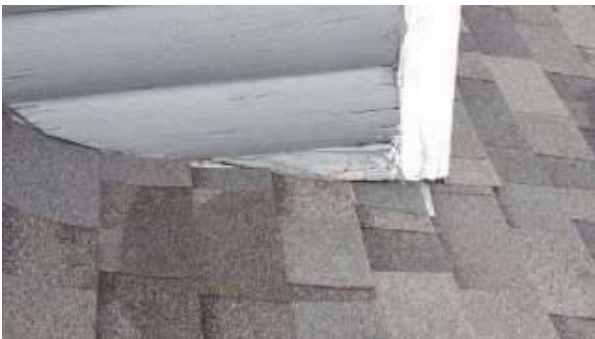
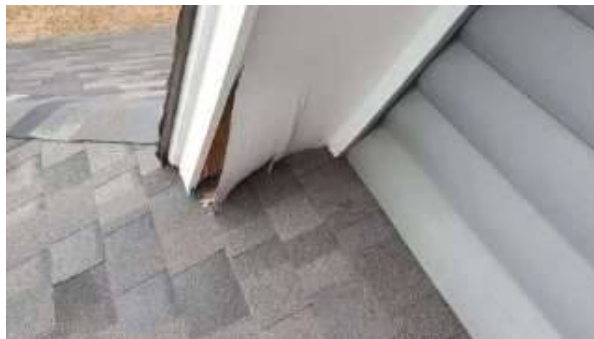
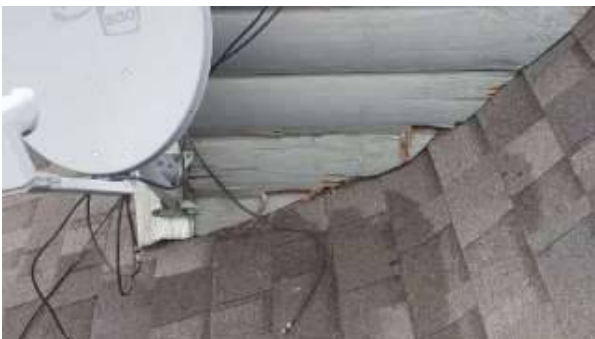
Fungal rot or significant water damage was found at one or more roof areas at barge boards, fascia boards and/or soffits. Recommend that a qualified contractor repair as necessary. For example, by replacing all rotten wood, priming and painting new wood and installing flashing.

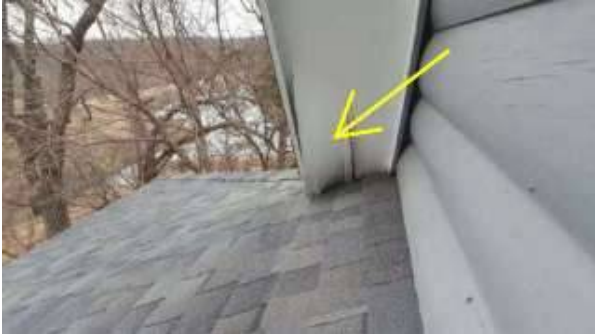
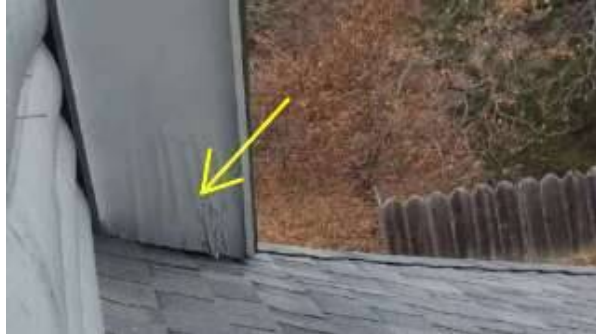
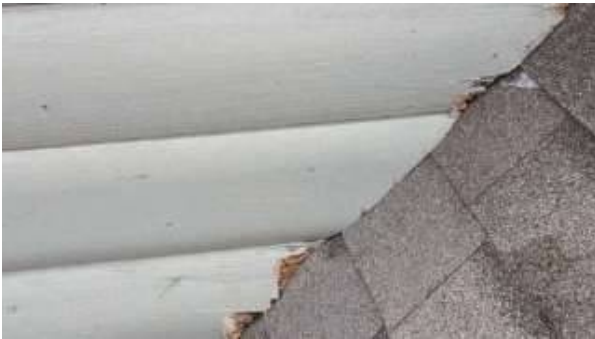
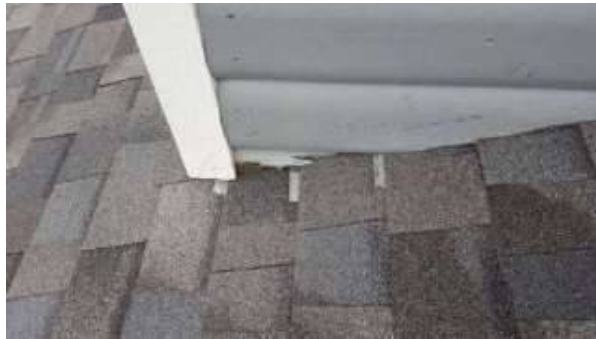
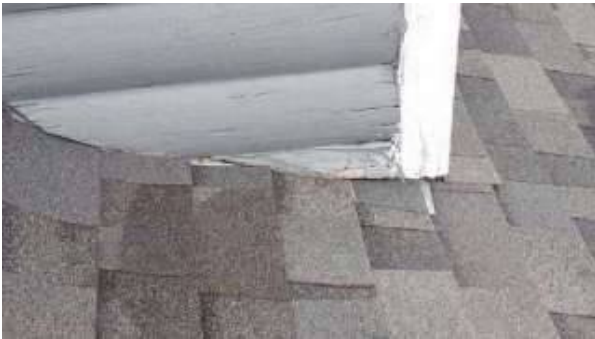
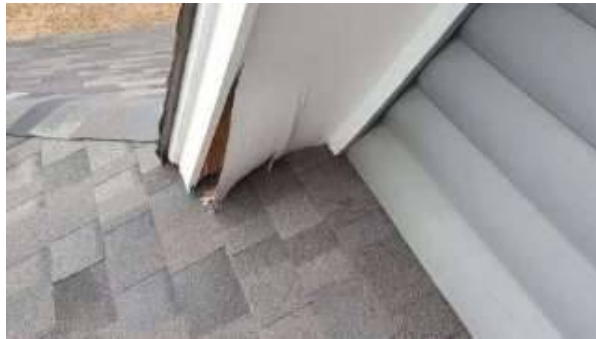
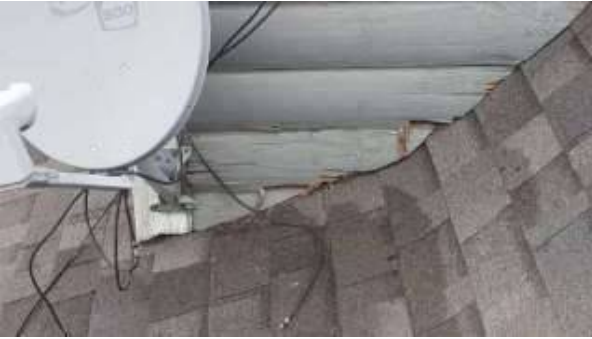
The siding on one or more exterior walls was in contact with or too close to roof surfaces below. This is a conducive condition for wood-destroying organisms. There should be a gap of 1 1/2 to 2 inches between a roof surface and siding above. The gap is meant to prevent water from

wicking up into the bottom edge of the siding and causing fungal rot, or damaging the siding. There may also be inadequate space for additional layers of roofing materials in the future. Recommend that a qualified contractor repair per standard building practices. For example, by trimming the siding.

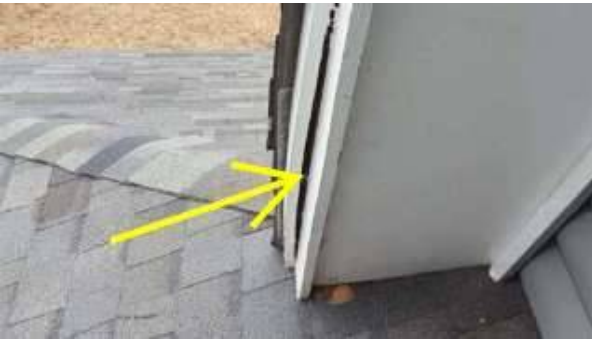
Photo 10-1

10) Loose shingle molding should be nailed up tight

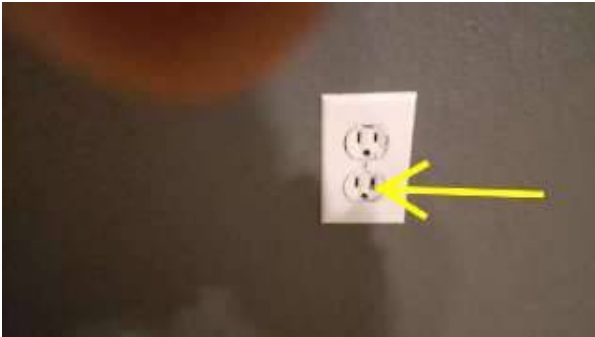
Photo 12-1

One or more receptacles were scorched. The wiring for these receptacles may be damaged due to overheating. Recommend that a qualified electrician replace such receptacles, evaluate related wiring and repair if necessary.

Lower wall in the master bedroom

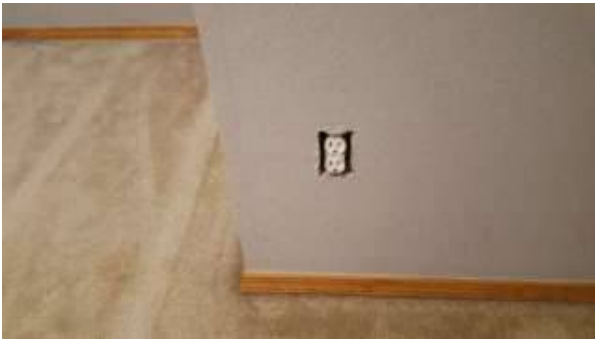
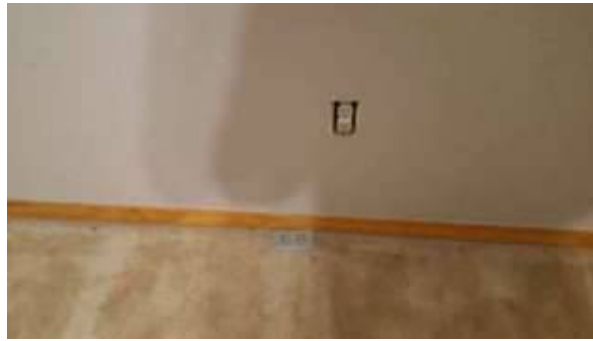
One or more cover plates for switches, receptacles or junction boxes were missing or broken. These plates are intended to contain fire and prevent electric shock from occurring due to exposed wires. Recommend that a qualified person install cover plates where necessary.

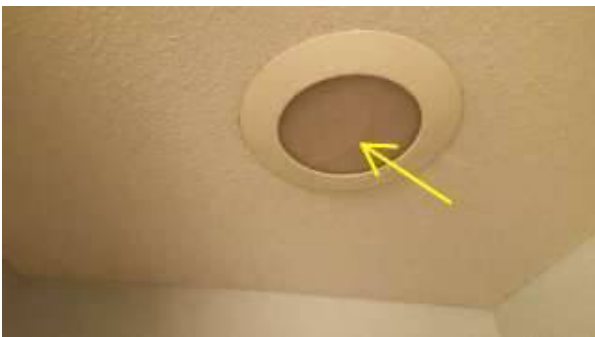
Photo 19-1

One or more globes or covers for light fixtures were missing or damaged. Recommend replacing as necessary to avoid exposed bulbs. With closet lighting or where flammable stored objects are near light fixtures, missing or broken covers can be a fire hazard.

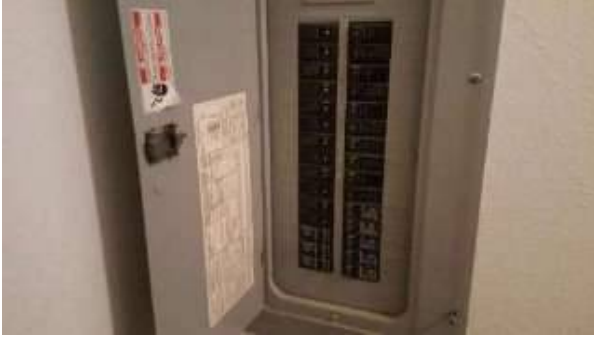
Photo 20-1

The legend for circuit breakers or fuses in panel(s) #A was missing, incomplete, illegible or confusing. This is a potential shock or fire hazard in the event of an emergency when power needs to be turned off. Recommend correcting the legend so it's accurate, complete and legible.

Evaluation by a qualified electrician may be necessary.

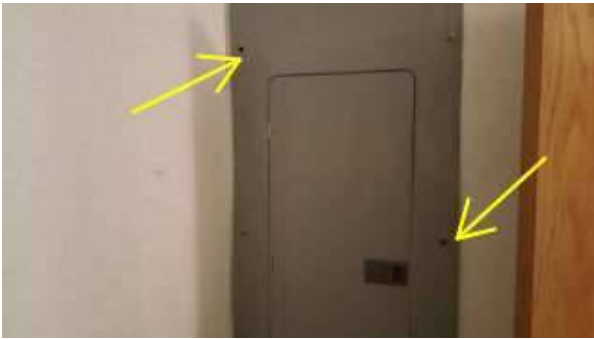
Photo 21-1

21) 🛠️ One or more screws that attach the cover or dead front to panel(s) #A were missing or not installed. Recommend installing screws where missing so the cover or dead front is secure. Only screws with blunt tips approved for this purpose should be installed, so wiring inside the panel is not damaged. Because energized wires may be located directly behind screw holes, the client should consider having a qualified electrician replace missing screws.

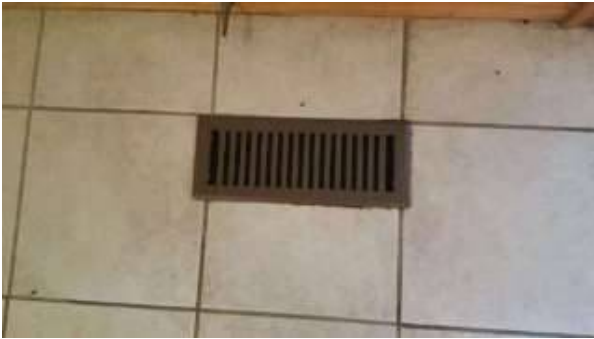
Photo 33-1

One or more air supply registers were damaged. Recommend replacing as necessary.

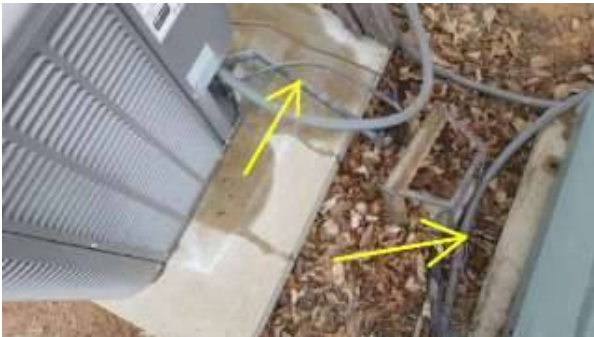
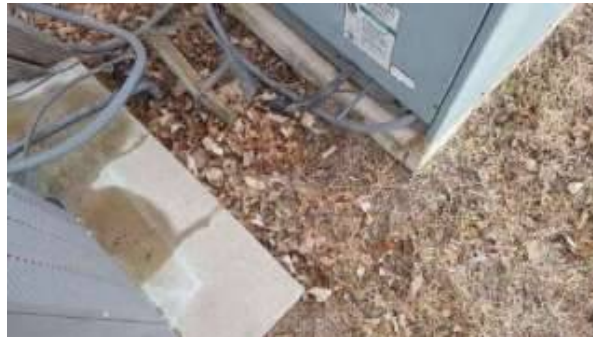
Insulation on the heat pump or air conditioning condensing unit's refrigerant lines was deteriorated or missing in some areas. This may result in reduced efficiency and increased energy costs. Recommend that a qualified person replace or install insulation as necessary.

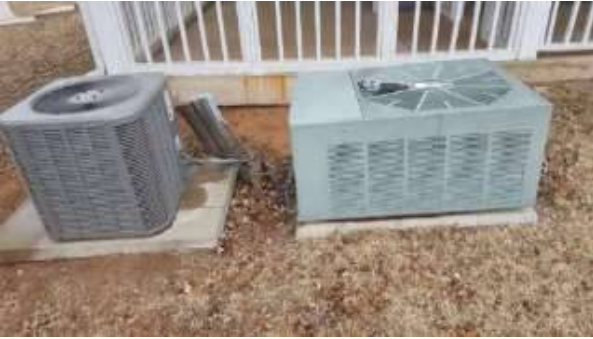
Photo 35-1

The pad for the heat pump or air conditioning condensing unit was not level and/or undermined. This unit requires adequate support. The compressor may be damaged if this unit is tilted 10 degrees or more. Also, the pad should elevate the unit above the soil to prevent corrosion. Recommend that a qualified person repair as necessary.

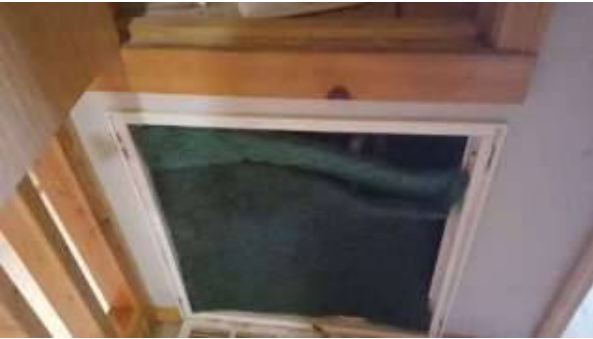
Photo 36-1

Recommend replacing or washing HVAC filters upon taking occupancy depending on the type of filters installed. Regardless of the type, recommend checking filters monthly in the future and replacing or washing them as necessary. How frequently they need replacing or washing depends on the type and quality of the filter, how the system is configured (e.g. always on vs. "Auto"), and on environmental factors (e.g. pets, smoking, frequency of house cleaning, number of occupants, the season).

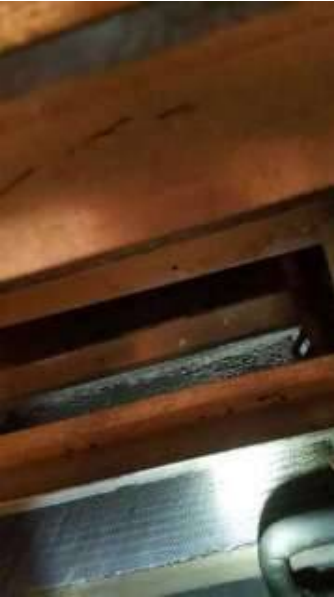
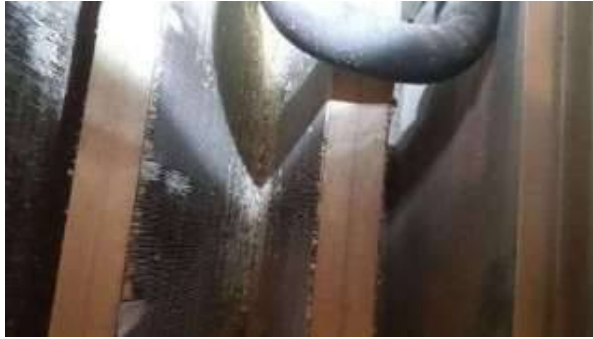
The cooling fins at the air handler evaporator coils were dirty. Recommend that a qualified person clean fins as necessary.

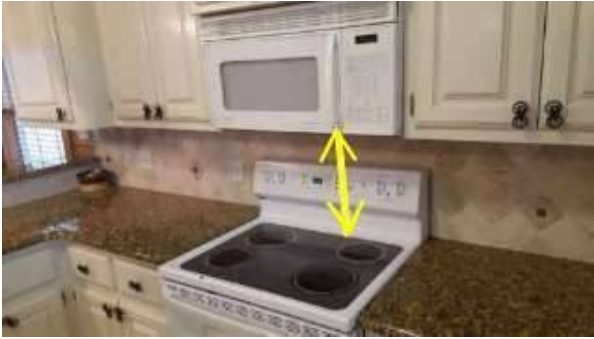
Photo 42-1

The clearance between the stove top and the base of the exhaust hood above was too low. While the recommended height varies per the hood manufacturer, standards usually call for a minimum of 24 inches of clearance. A low hood height can restrict visibility of the stove top.

Recommend that a qualified contractor repair per standard building practices.

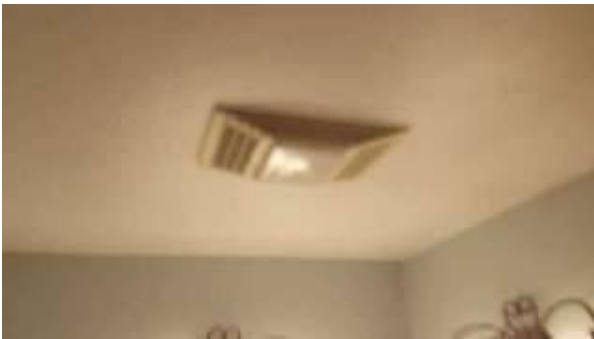
Photo 45-1

45) 🛠️ The exhaust fan at location(s) #A was inoperable. Moisture may accumulate and result in

mold, bacteria or fungal growth. Recommend that a qualified person clean, repair or replace fans as necessary.

The heat part of the heat,light, vent did not work

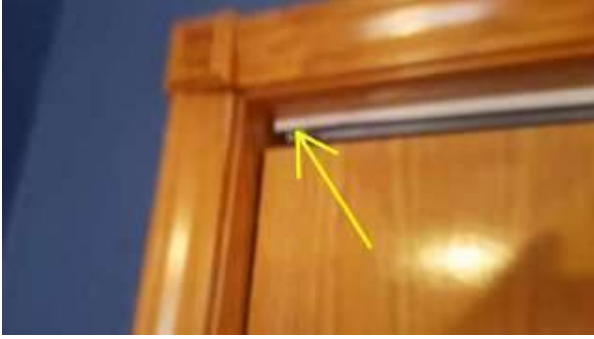
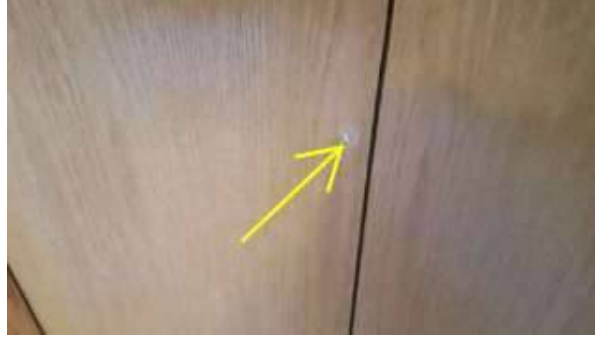
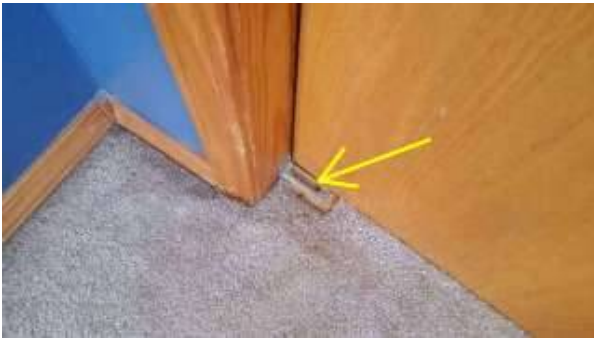
47) 🛠️ Some interior door hardware () were damaged and/or missing. Recommend that a qualified

person repair or replace as necessary.

Door knob missing

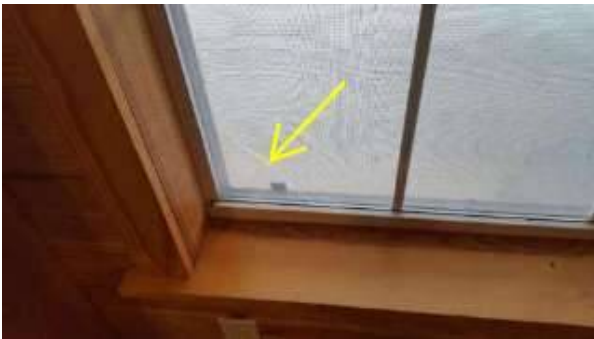
Photo 49-1

Glass in one or more windows was cracked, broken and/or missing. Recommend that a qualified contractor replace glass where necessary.

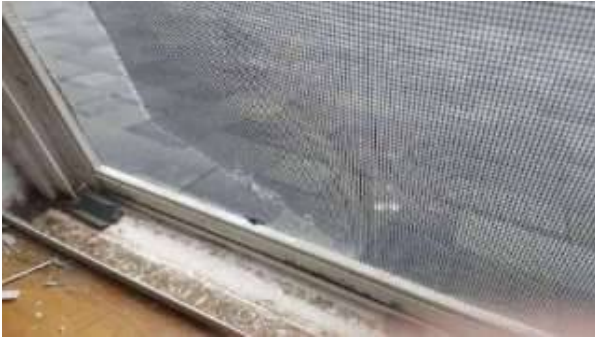
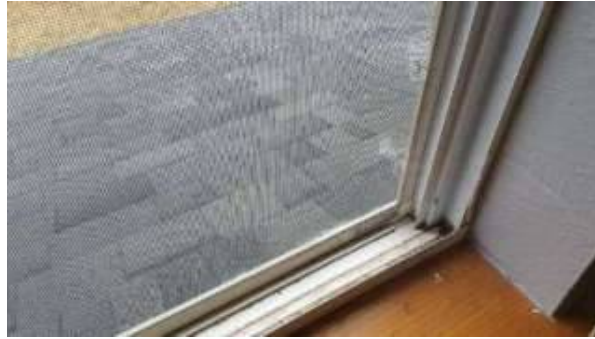
One or more window screens were damaged or deteriorated. These window(s) may not provide ventilation during months when insects are active. Recommend replacing window screens as necessary.
